# Manhole Inspection Summary

Manhole # S41U1\_009MH

Insp Date: **4/30/08 9:52 AM**

**Location** Address: **Across from 501 Chesapeake Ave.**

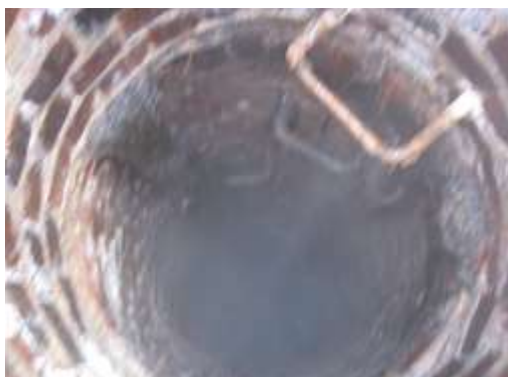
Steps

Count: **11** Missing: **0** ☐ Corroded

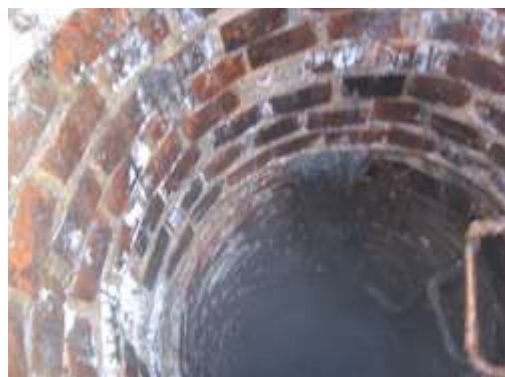
Defect 1

Condition: ☐ Sound ☐ Cracked ☒ **Root Intrusion** ☐ Loose Brick ☐ Deteriorated

Infiltration: ☐ None ☐ Joint ☒ **Cracks** ☐ Mortar ☐ Roots ☐ Wall

Roots

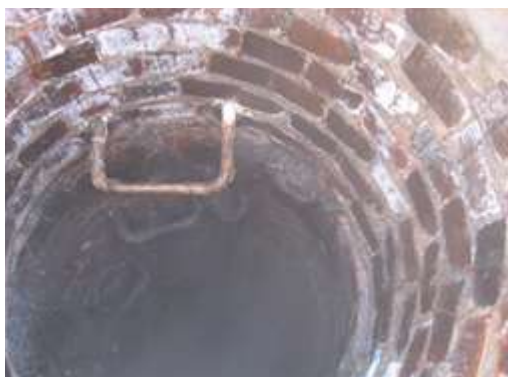
Defect 2

Roots

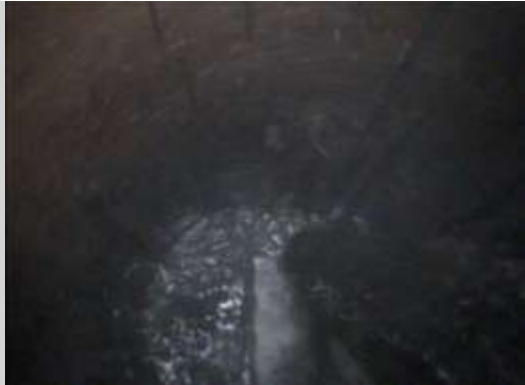
12 O'Clock Outflow

12 in. Circular Gravity Sewer  
Pipe Out @ 12 O'Clock

Pipe Height: **12** (in.) Rod and Bar (Angled)  
Pipe Material: **Clay** ☐ Pipe Lined  
Invert Depth: **23.78** (ft.) Flow Characteristics: **Turbulent**  
Deposits: ☒ None ☐ Mud ☐ Sludge ☐ **Debris** ☐ Grease  
Silt Depth: (in.) Deposits Extent:  
Infiltration: **None** Pipe Seal Cond: **Unknown**

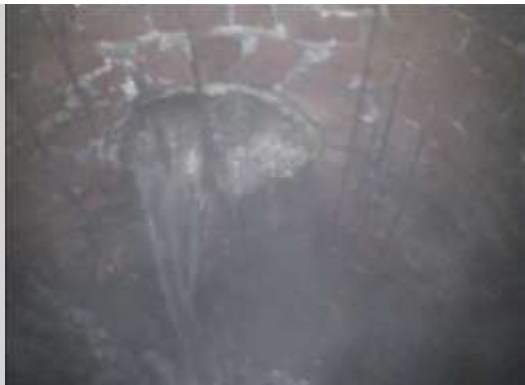
7 O'Clock Inflow

12 in. Circular Gravity Sewer  
Pipe In @ 7 O'Clock

Pipe Height: **12** (in.) Rod and Bar (Angled)  
Pipe Material: **Clay** ☐ Pipe Lined  
Invert Depth: **13.44** (ft.) Flow Characteristics: **Turbulent**  
Deposits: ☐ None ☐ Mud ☐ Sludge ☒ **Debris** ☐ Grease  
Silt Depth: **1** (in.) Deposits Extent: **Medium**  
Infiltration: **None** Pipe Seal Cond: **Sound**
